# ASSESSMENT OF DAMAGE TO THE MEEKINS FAMILY CEMETERY, MARLBORO COUNTY, SOUTH CAROLINA

## RESEARCH CONTRIBUTION 92

**Chicora Research Contribution 92**

**September 11, 1992**

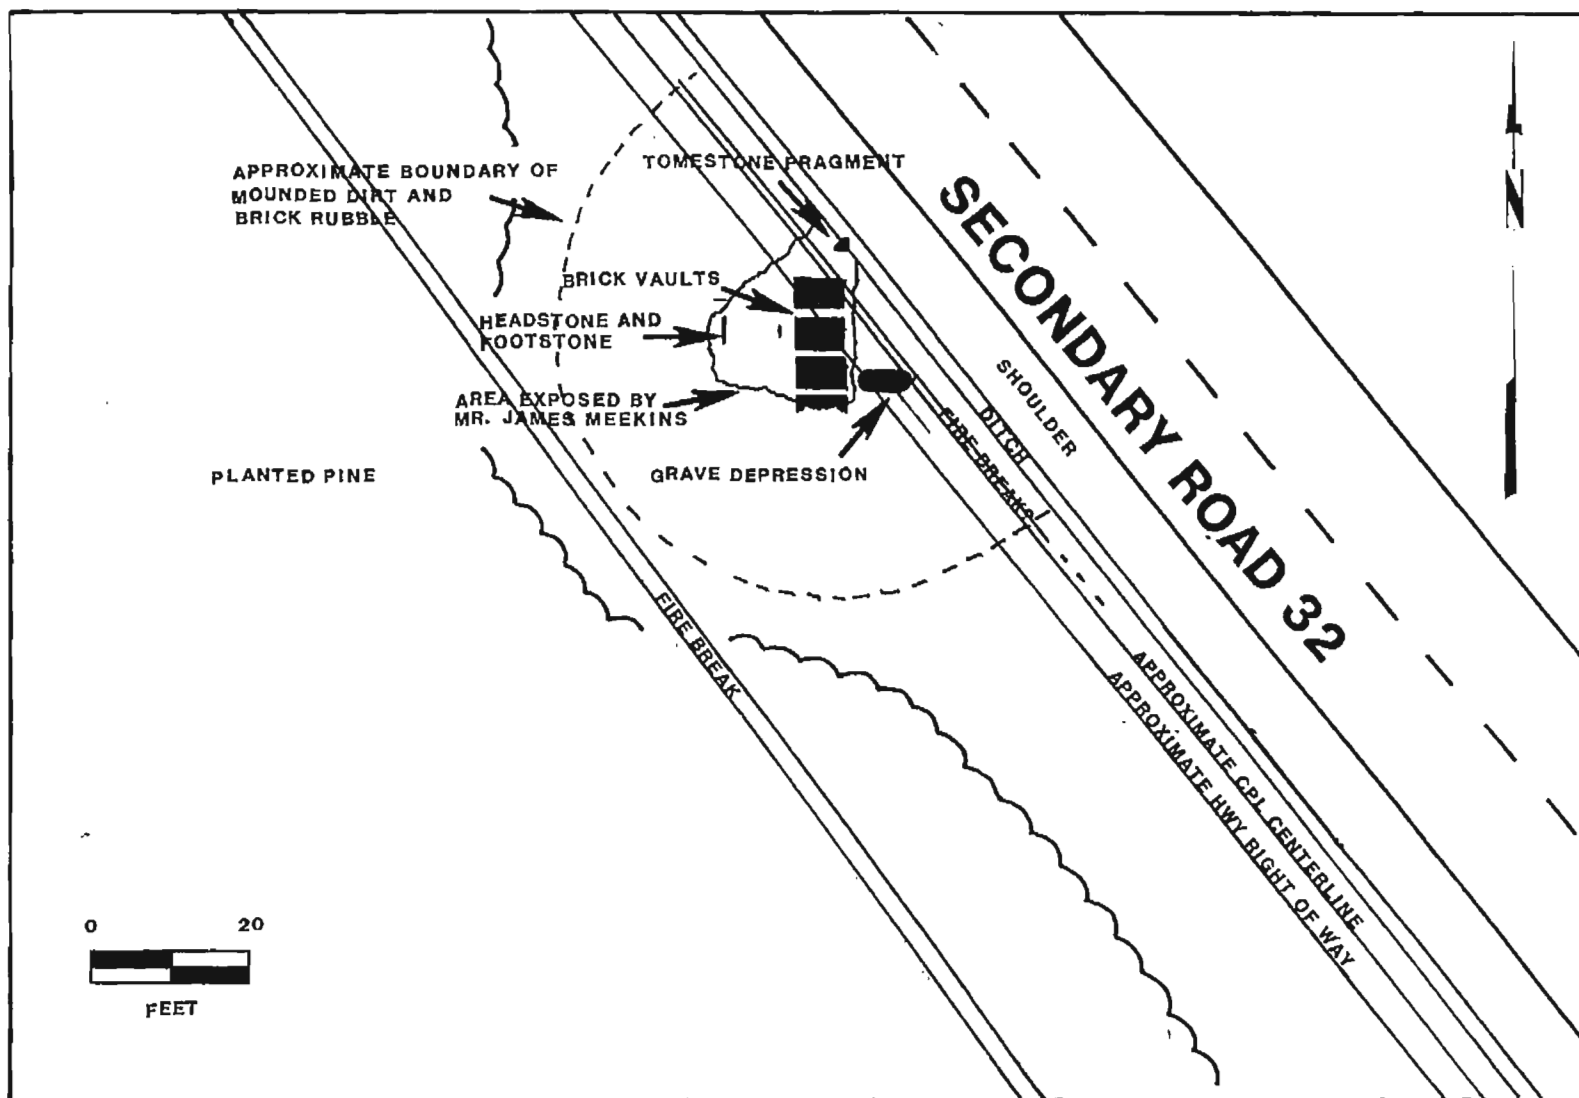
Figure 2. Approximate location of features associated with the Meekins cemetery.

Initial walk over of the area indicated that the overburden covers an area from the ditch to an area of planted pines approximately 75 feet to the west. To the north and south, planted pines extend closer to the road area, and it is possible that they mark the boundaries of the cemetery. From the planted pines looking toward Secondary Road 23, the overburden can be easily seen. It appears that this fill only covers the cemetery area, since further south near Five Forks Road overburden is not obvious. Our best estimate is that at least 2 feet of fill is present over much of the cemetery, although we have not undertaken any excavations, and this is based only on a visual examination and the work that has been conducted by Mr. Meekins. Some evidence of ditching can also be seen along the edge of the planted pines, and another probable ditch can be seen along the road edge (Figure 2).

This investigation revealed that Mr. Meekins had found three side by side brick vaults and it appears that more are present, based on dense concentrations of brick rubble in other areas of the cemetery. One un-vaulted grave associated with Christian Meekins was found just west of the vaults. The markers consist of a broken headstone and a slightly displaced footstone. To the south and east of the vaults is a depression, oriented east-west as the other graves are. All or part of the cemetery had been surrounded by a wrought iron fence, and small sections of the fence were found during Mr. Meekins initial clean up efforts. There is also evidence that at least one or two graves (and possibly more) have been heavily impacted by the cutting of the road ditch adjacent to Secondary Road 23.

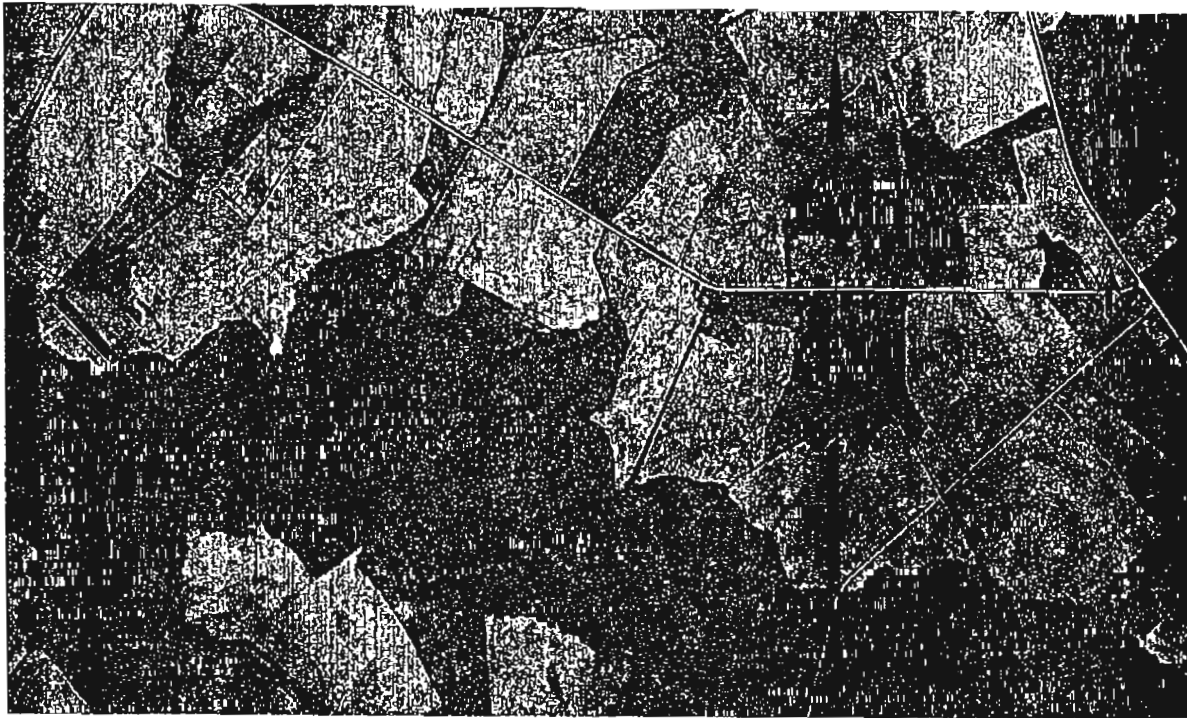
Figure 3. 1949 aerial photograph of the cemetery area.

A 1917 soil survey map does not show the cemetery, nor does the 1972 USGS topographic map. However, a series of aerial photographs give indication of the cemetery's location and changing land use patterns. A 1949 aerial photograph shows the area in fields. The cemetery appears as a small clump of trees at the edge of Secondary Road 23 (Figure 3). The 1964 soil survey aerial photograph shows virtually no change in land use. Again, a small clump of vegetation can be seen in the area of the cemetery (Figure 4). Approximately ten years later, the area of the cemetery is shown as wooded (Figure 5), and today the area behind the cemetery is planted pine.

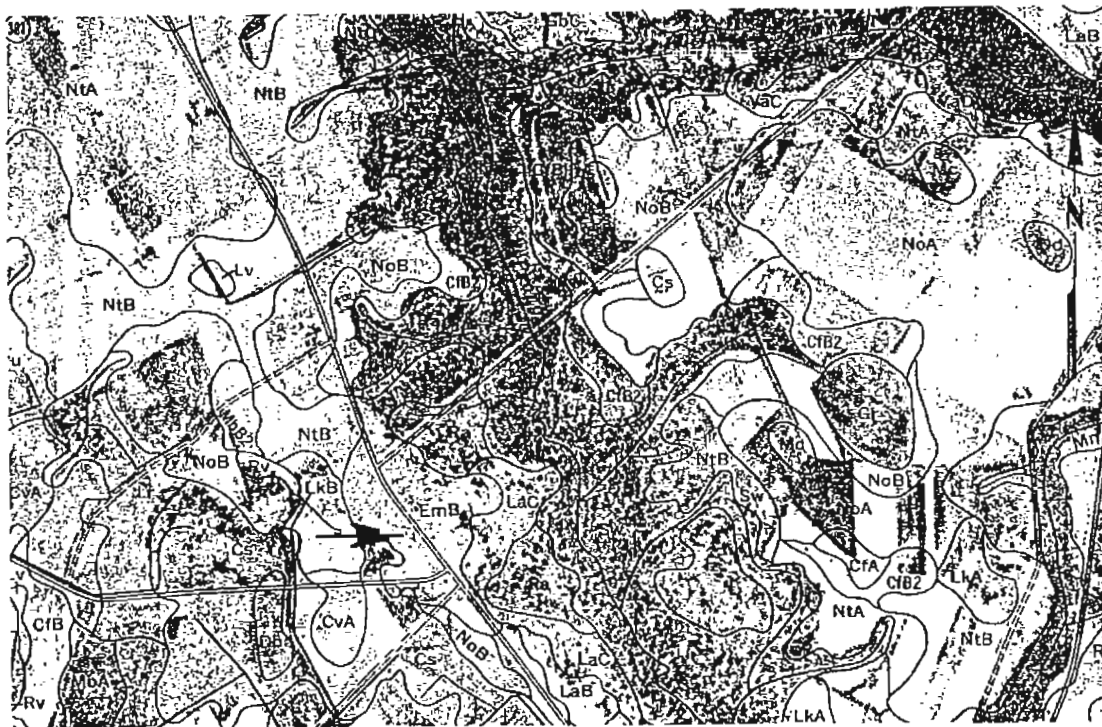
Figure 4. 1964 aerial photograph of the cemetery area.

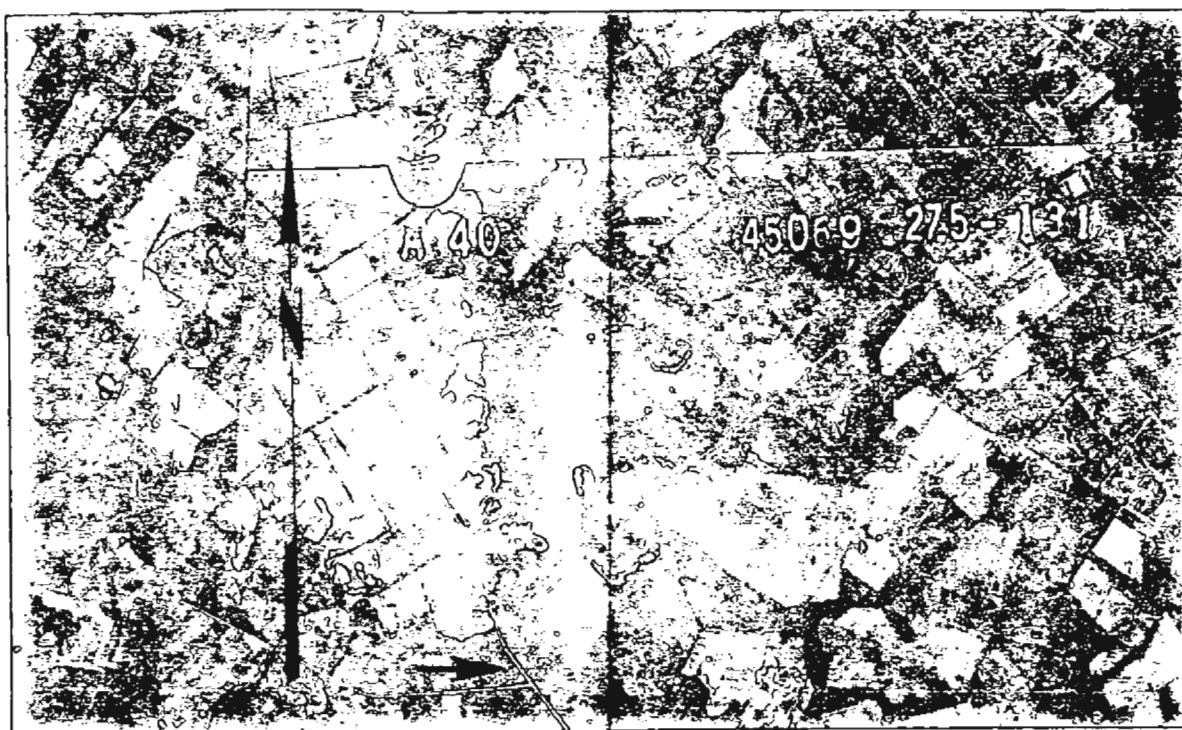
Figure 5. 1975 aerial photograph of the cemetery area.

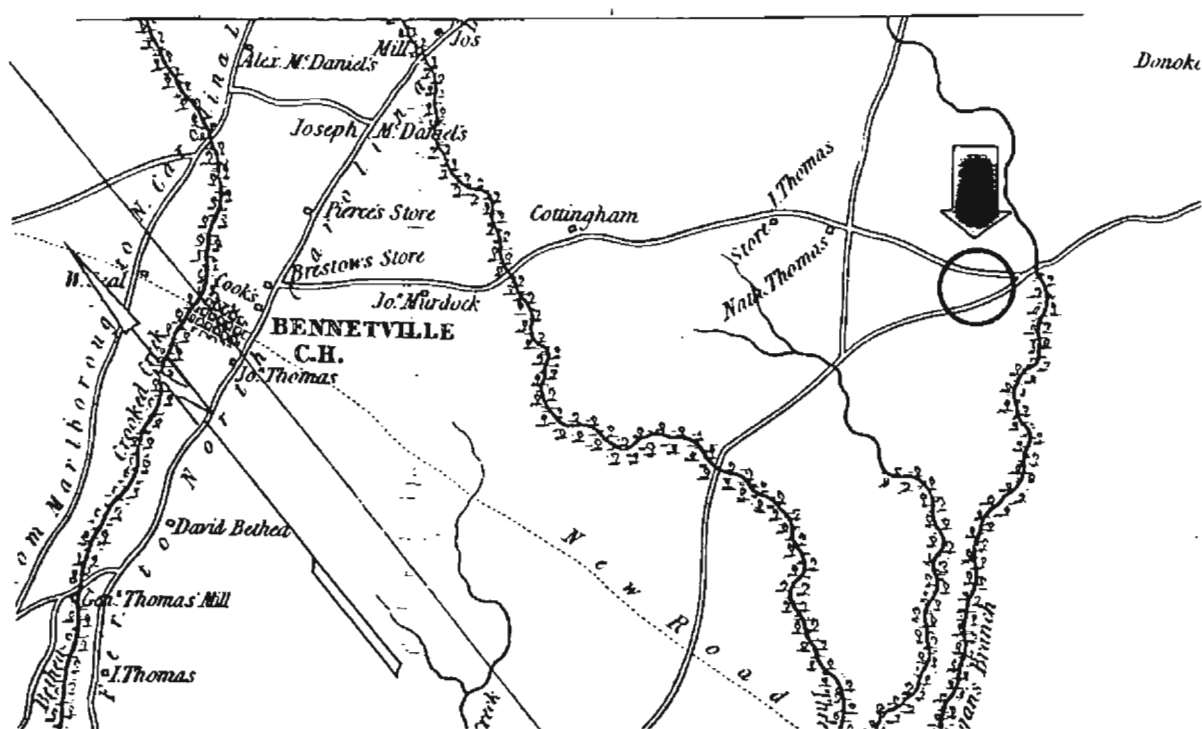
Figure 6. Mills Atlas showing the area in the 1820s.

Secondary Road 23 has a long history. While the initial date of construction is unknown, the present road closely follows the alignment of a road shown on Mills' Atlas from the 1820s (Figure 6). Some disturbance to the cemetery could have occurred during the 1958 improvements. The 33 foot right-of-way on either side of the center line puts the S.C. Department of Highways and Public Transportation boundary through the cemetery. It is likely that ditch construction for road drainage damaged several graves. Future cleaning and maintenance of these ditches will continue this destructive process.
